Understanding the Root Causes of Axial Cracking in Wind Turbine Gearbox Bearings

Doug Herr – General Manager – AeroTorque Corporation
David Heidenreich – Chief Engineer - AeroTorque Corporation

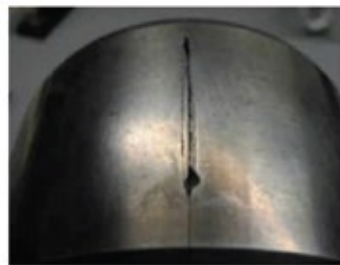
Fig. 1 A single axial crack that has propagated completely through the inner ring.

Why does axial cracking failure mode occur in the inner ring of a bearing? This is mainly due to the inner ring being typically mounted to a shaft with an interference fit. The ring is heated during assembly onto the shaft. When the ring cools, it shrinks – holding the ring in place, but also creating tensile stress in the ring that increases the possibilities for axial cracking.⁶ An axial crack failure of the inner ring can be caused by excessive hoop stresses during installation but this does not appear to be the general case in the wind industry. Microscopic, white-colored areas at the edge of the cracks when the bearings are sectioned and etched are the key indicator that these are not merely standard hoop stress failures. These cracks are termed White Etch Cracks (WEC) and are commonly found in through-hardened bearing races.

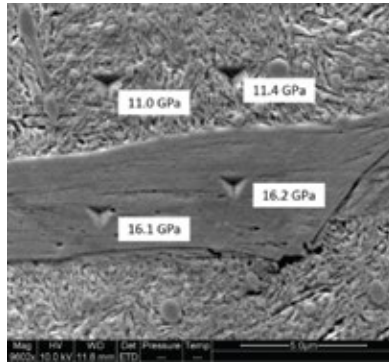
Fig. 3. A microscopic WEA formation with nano hardness measurements showing a 44% increase in hardness. Courtesy A. Greco et al¹

Once an event occurs that initiates the subsurface WEA formations, normal rolling action of the bearing can cause cracks to start at the junction of these inclusion-like areas. The crack will inevitably propagate to the surface and become a White Etch Crack (WEC), which can grow axially across the raceway and prematurely fail the bearing.

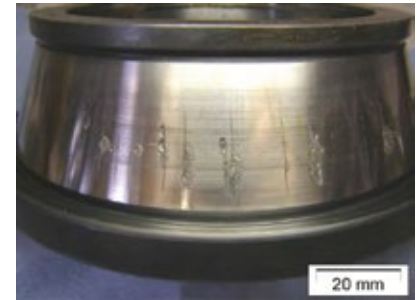
Fig. 4 shows White Etch Cracks (WECs) and White Surface Flaking (WSF) on the inner ring of a tapered roller bearing. Evidence suggests that both were initiated by WEA microstructural alterations in the steel subsurface.

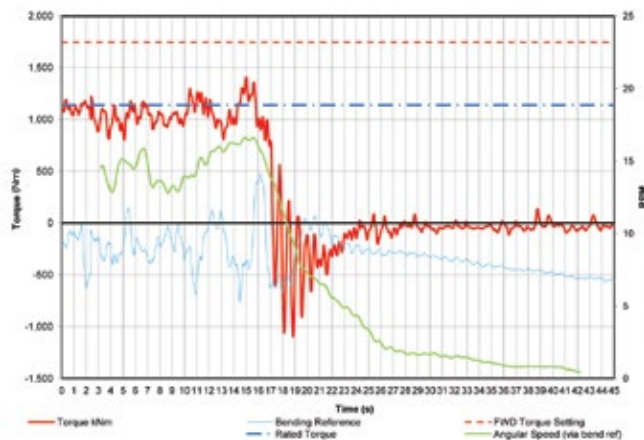
Fig. 5 – A Transient Torque Reversal (High Wind) event captured on a 2.0MW wind turbine.

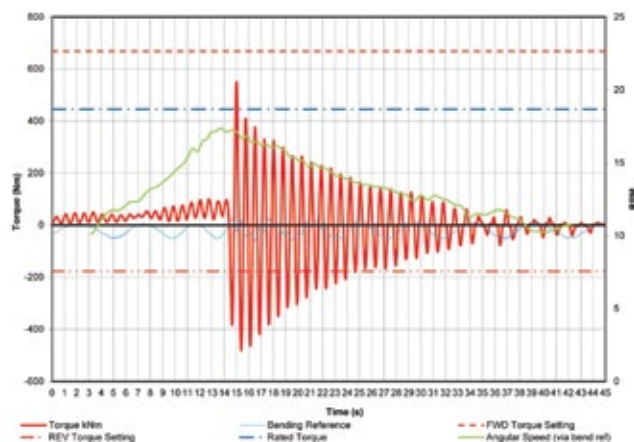
Fig. 6 – A Transient Torque Reversal (High Wind) event on 1.0MW wind turbine.

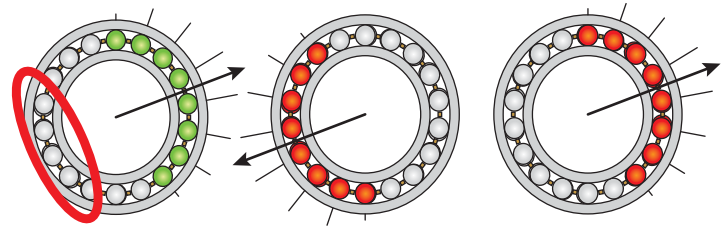
Fig. 7 Aligned rollers are in green load zone. Misaligned rollers are 180° opposite and are circled in red. In a TTR, these unaligned rollers are suddenly loaded repeatedly.

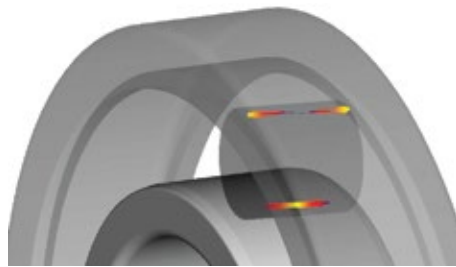
Fig. 8 – Image showing the areas in a bearing with the highest stress during a Transient Torque Reversal.

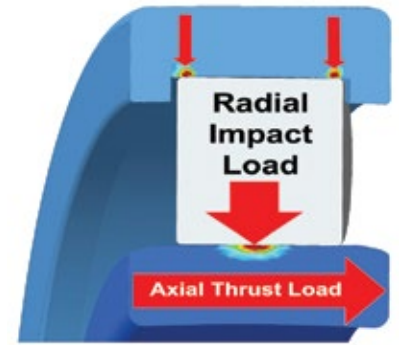
turbines. In gearboxes with helical gearing, every cylindrical bearing will see high axial loads simultaneous with the radial loads impacting misaligned rollers. See Fig. 9. These rollers may slip axially and damage the raceway surface, shortening bearing life through pitting and spalling. The sliding can also result in scuffing of the raceway causing microscopic cracks that allow subsurface entry of water or aggressive oil additives to initiate hydrogen induced WEA. If the radial impact load is so high that the roller

breaks through the oil film, it can create mixed friction sufficient to prevent slipping axially. Axial subsurface stresses will be added to the Hertzian stresses from the radial impact, magnifying the stresses. The strain rate would be magnified, as well. If this exceeds a threshold where WEA microstructural alterations could form, it may explain why WEA damage is common in wind turbine gearboxes and rare in most other bearing applications. Tapered roller bearings can also be damaged by the effects of load reversals. High speed and intermediate speed bearings typically are not preloaded (due to thermal constraints) and see axial movement and impact loads.

Fig. 9 – Image showing the simultaneous radial impact and axial loading of the misaligned roller.

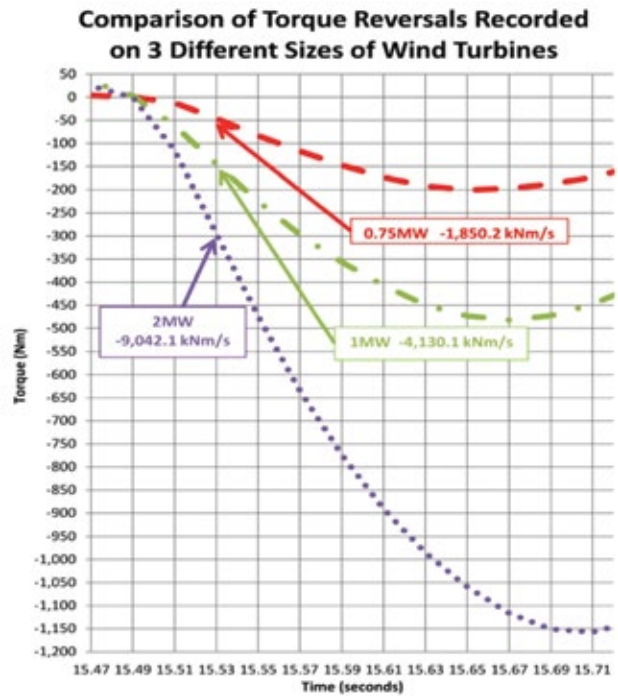
Fig. 12 compares the relative torque magnitude and the rate of torque change during rapid reversals of three different sized turbine models. High resolution torque monitoring equipment recorded torque reversals that approximated the turbine rated torque at the high speed shaft on ¾ MW, 1 MW and 2 MW turbines. The torsional natural frequencies of the turbines during braking were all similar with oscillation periods about 0.75 second-per-cycle. The higher torque loads of the larger turbines can be accommodated in the sizing of the bearings but the oil film thickness will not increase. Any roller misalignment can more easily cause high local-contact stress during a torque reversal. The difference in the rate of increase of the reverse torque during the torque reversal may be an even bigger issue (comparison rate is noted in Fig. 12), as it directly relates to the strain rate in the raceway as the rollers impact. There is a threshold in rapid plastic deformation (adiabatic shear) where the instantaneous heat created causes the microstructural alteration of the base material. Could the increasing strain rate of larger turbines be exceeding that threshold? During rapid load zone reversals, could the rapidly increasing load on the rollers be creating fast enough plastic deformation to be transforming a microscopic sliver of the bearing steel to a super-hard ferrite WEA inclusion? Certainly all the elements for WEA microstructural alterations are present simultaneously for an instant. The torque reversal takes up the gear backlash and rapidly **impacts** the idling rollers on the unloaded side of the bearing. The misaligned rollers can make the stress concentration and the plastic deformation under the rollers worse and initiate mixed friction contact. Simultaneous reversal of the axial load on the bearing due to the helical gearing causes **surface traction** and additional stress at the inner raceway subsurface. The resulting **high strain rates**

Fig. 12 – High resolution torque reversal recordings on 3 sizes of wind turbines showing the rate of change in torque. The steeper slope indicates significantly higher strain rates.

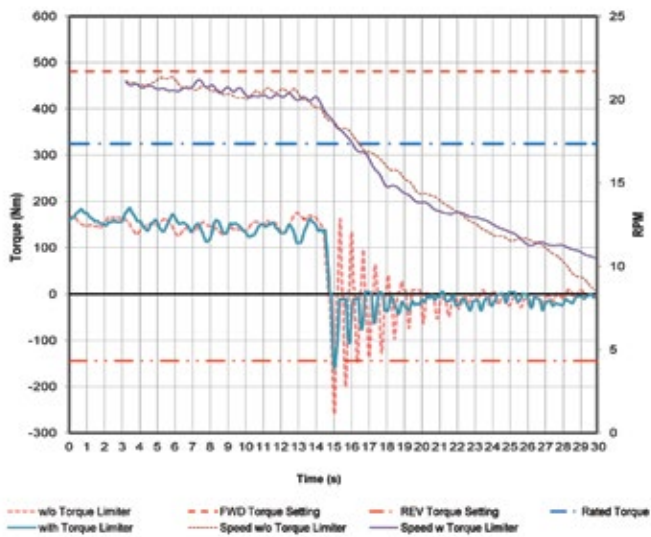
Fig. 13 – Dampening effect of reducing transient torque reversals to 40% of nominal torque.

cracks. The asymmetric torque limiter actually addresses the root cause – the rapid and severe loading that can initiate the stress-induced WEA damage. Simple frictional slip torque limiters are commonly used to protect wind turbine drive systems from severe torque overloads, such as generator short circuits. No evidence has been found that a basic torque limiter can provide protection against axial cracking. An asymmetric torque limiter has a much lower slip setting in reverse. Field testing of wind turbines with and without the asymmetric torque limiter has demonstrated its ability to significantly reduce the maximum reverse torque and rate of torque increase, thus reducing maximum stress and strain rate caused by the rollers impacting on the bearing raceway during the torque reversal. This approach would also dampen torsional vibrations to reduce the number of reversals. See Fig. 13. Field data from a 750 KW turbine (Fig 14) shows the effectiveness of the asymmetrical torque control in reducing the maximum reverse torque and the maximum rate of reverse torque increase. Note that both the magnitude of the stress and the maximum strain rate of the rollers impacting the raceway are reduced by over 50%; a 75% reduction of the instantaneous impact and deformation energy.

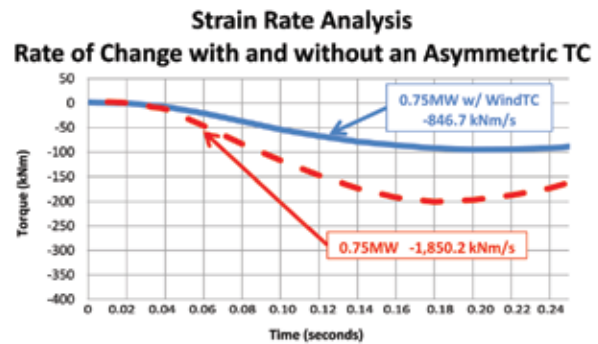
Fig. 14 - Comparison of torque reversal magnitude and rate of change for a 750 KW turbine with and without an asymmetrical torque control.

This deformation energy reduction can be achieved on larger turbines in a similar manner with the likely outcome of dramatically reducing the axial cracking. If asymmetric torque control can keep impact loads below the threshold where WEA microstructural alterations are initiated, super-hard WEA slivers could never form under the raceway, and axial cracks in gearbox bearings would cease to be a prominent mode of failure affecting the cost of wind turbine energy.
