AeroTorque – Torque Monitoring & Control Case Study

BETA 1 TEST SITE

By Doug Herr, AeroTorque, Wind Product Manager
Dave Heidenreich, Chief Engineer, Wind Products

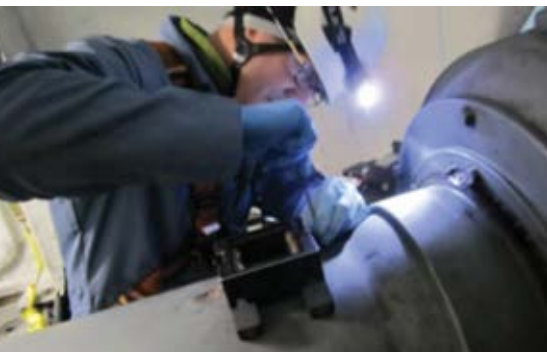
The **WindTM™** monitor was magnetically mounted to the main shaft of the turbine, allowing for quick installation and removal. The on-shaft unit communicated to a transceiver that allowed remote access to the data accumulated via cellular network. Strain gauges on the main shaft measured both torsion and bending. The cycling rate of the bending load in the shaft provided a measurement of the speed.

AeroTorque, with its testing partner JR Dynamics, developed a set of test gear, called WindTM™, a torque monitoring device, which allows for real-time continuous torque measurement in a wind turbine drivetrain.

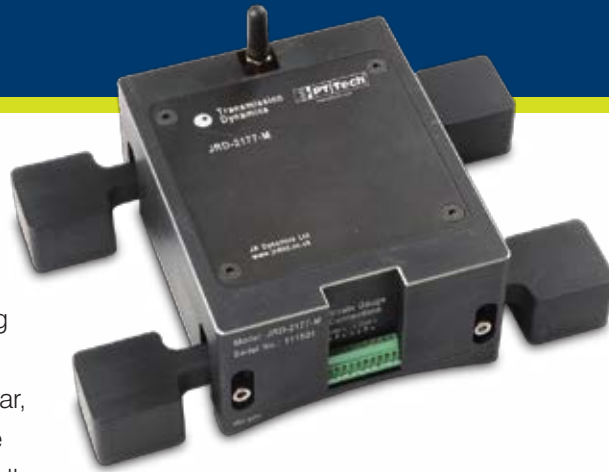
Looking for transient event data with continuous measurements can be like looking for a needle in a haystack. The **WindTM™** was designed to only store the worst 100 forward torque events and worst 100 reverse torque events over any monitoring period. It does this by continuously feeding the data into a buffer. When a significant torque

transient occurs, the WindTM™ puts a marker the 8 seconds prior to the event and continues recording for a total of 45 seconds. It discards all the data in between the significant 200 events. The events are also time-stamped to allow for syncing with SCADA and other data sources.

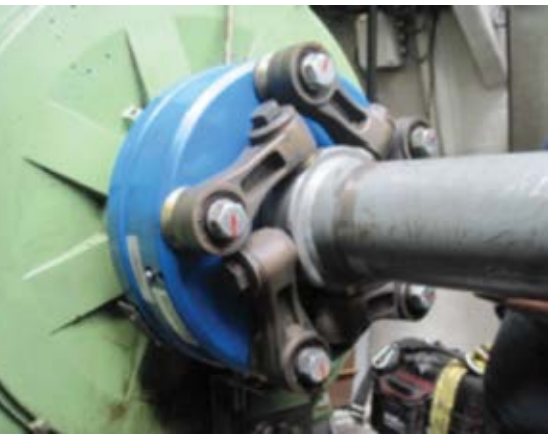
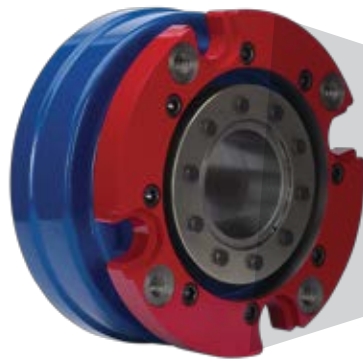
WindTC™ Installation: After seven months of monitoring, the new **WindTC™** was installed on the test turbine. In addition, a nearby turbine was installed with a second **WindTC™**, torque monitoring device. This allowed for direct comparison testing of turbine drivetrain loads in the same events.

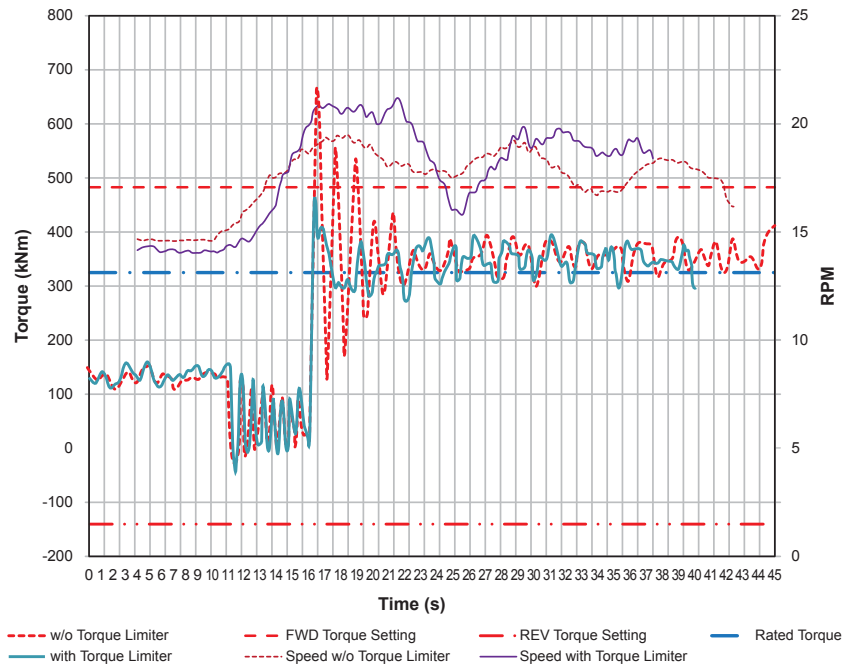
The NEG Micon NM 48 is a two-speed turbine that is not equipped with any torque limiting device. This plot shows the comparison during an upshift event of the two turbines. The generators are operating at low speed. As wind speed increases, the low speed generators are disengaged, and the wind turbine speeds up as the high speed generators contactors engage.

The turbine without the **WindTC™** protection sees a torque spike of 200% when changing from one set of contactors to another. The turbine with the **WindTC™** is protected from this spike at its 150% setting and also prevents significant additional oscillations that are potentially damaging, even though they don't cross the zero torque line.

The WindTC™ also provided torque protection in the forward direction. During phase II, some up-shifting events on the unprotected turbine resulted in 200% forward torque overloads. The turbine with the WindTC™ during the

same event had forward torque overloads effectively limited to 150% of rated turbine torque.
