Understanding the Root Causes of Axial Cracking in Wind Turbine Gearbox Bearings

Doug Herr – General Manager – AeroTorque Corporation
David Heidenreich – Chief Engineer - AeroTorque Corporation

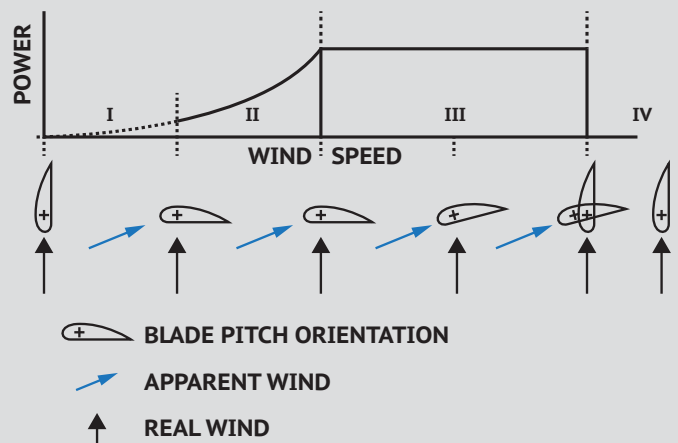
Fig. 10 – Typical Power Curve and pitch angles of modern wind turbines

Pitchable blades allow today's wind turbines to achieve close to the ideal power curve shown in Fig. 10. Blade pitch control is important to maximizing the energy capture from the wind. In addition, it is critically important as the primary safety braking system for protecting the turbine from damaging wind loads and overspeed in the event of any turbine subsystem failure that prevents continued operation. Fig. 10 also shows the pitch angles of a typical modern turbine. At low wind speeds, the blades start out in a fully feathered position almost 90 degrees to the plane of the rotor swept area. In region II, the blades rotate to almost zero degrees pitch angle to extract the maximum power, capturing close to 50% of the wind's available power. In region III, the blades are pitched back to protect the turbine from high stresses as it strives to control and maintain full rated power. At cut-out speed, the blades are quickly pitched to provide braking to decelerate the turbine drive system.

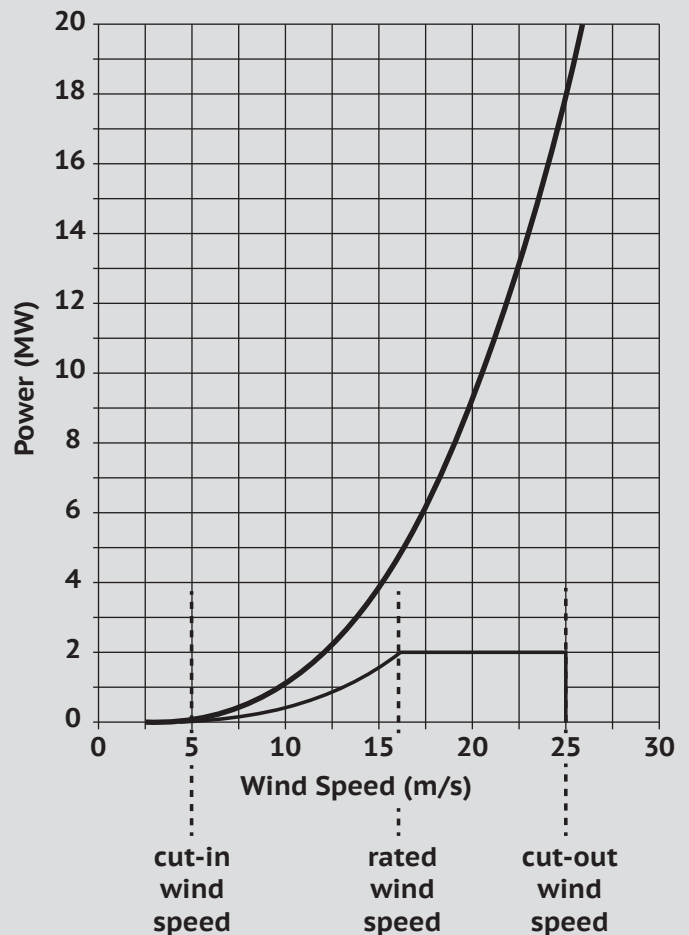
Fig 11 – Turbine power curve versus available wind

The Fig. 11 view of the power curve masks the challenge of protecting the turbine from damage during high and turbulent winds. Fig. 14 shows the turbine power curve compared with the wind's available power. As the winds approach the typical cut-out speed of 25 mps (55 mph), the turbine may use less than 10% of the wind's available power. The blades must be pitched to the precise angle to effectively spill wind power equal to 10 times the turbine's rated power and protect the drive from excessive loads.

With longer blades, the cut-in speed and the rated power speeds can be achieved at even lower wind speeds – dramatically improving the annual energy output and financial performance projections. But the excess wind power at cut-out speed that must be safely spilled over the edge of the blades may be even greater than 10 times the turbine's rated power.
